ENGINE MANAGEMENT SYSTEM - V8

Crankshaft speed and Position (CKP) sensor (C0168)

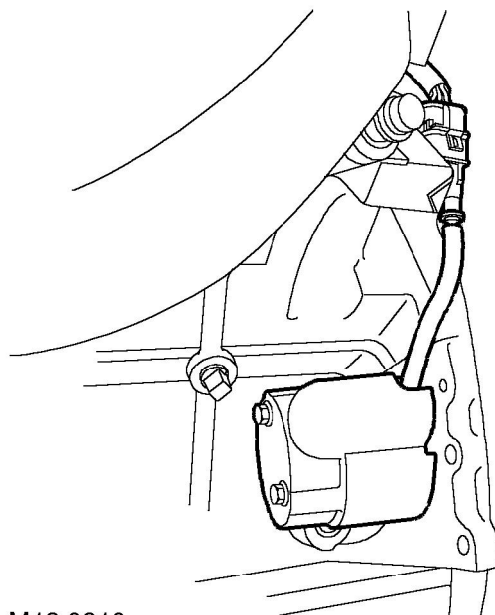
M18 0310

The CKP sensor is located towards the rear of the engine below cylinder number 7, with its tip adjacent to the outer circumference of the flywheel. The CKP sensor is the most important sensor on the vehicle and without its signal the engine will not run. The signal produced by the CKP sensor allows the ECM to determine crankshaft angle and speed of rotation. The ECM uses this information to calculate ignition timing and fuel injection timing.

The CKP sensor works as a variable reluctance sensor. It uses an electromagnet and a reluctor ring to generate a signal. As the reluctor ring passes the tip of the CKP sensor the magnetic field produced by the sensor is cut and then re-instated. The ECM measures the signal as an ac voltage.

The output voltage varies in proportion to engine speed. The reluctor ring has a set tooth pattern, 60 teeth are spaced at 6° intervals and are 3° wide, two teeth are removed to provide a reference mark at 60° BTDC for number 1 cylinder. There is no back up strategy or limp home facility if this sensor fails, the engine does not run.
