**RATIO CONTROL MOTOR**

Service repair no - 41.30.03

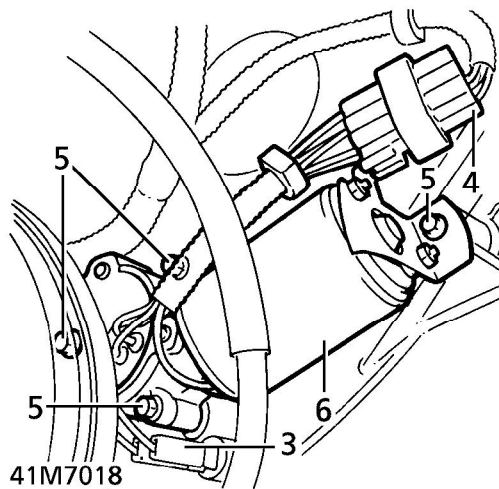
1. Raise vehicle on four post lift.
2. Disconnect battery negative lead.
3. Disconnect temperature sensor.
4. Disconnect motor multiplug.
5. Remove 4 bolts securing motor to transfer gearbox.
6. Remove motor.

7. Fit motor and engage to drive spindle.
8. Tighten bolts to **10Nm (7 lbf.ft)**.
9. Connect motor and temperature sensor.
10. Reconnect battery negative lead.
11. Lower vehicle.

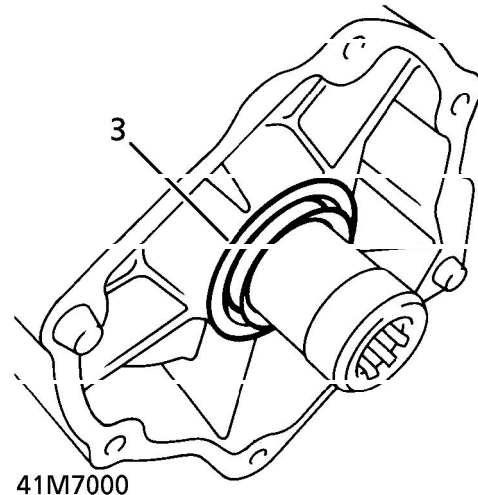
1. Disconnect battery negative lead.
2. Remove transfer box. **See this section.**
3. Lever seal from location in transfer box.

**CAUTION:** Ensure seal location does not become damaged.

4. Ensure mating faces are clean.
5. Lubricate seal lip with transmission fluid.
6. Using LRT-41-011, fit seal to transfer box.
7. Fit transfer box. **See this section.**
8. Reconnect battery negative lead.
