419-01B

Intermittent Passive Entry Operation

Intermittently, the passive unlock feature does not work unless the smart key is in the customers hand, close to the vehicle.

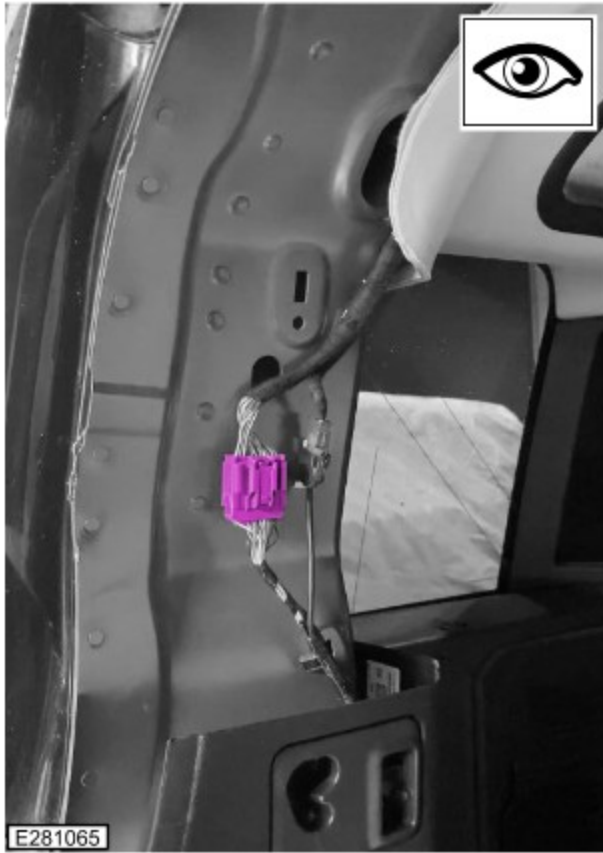
7.

Disconnect electrical connector (C49D).

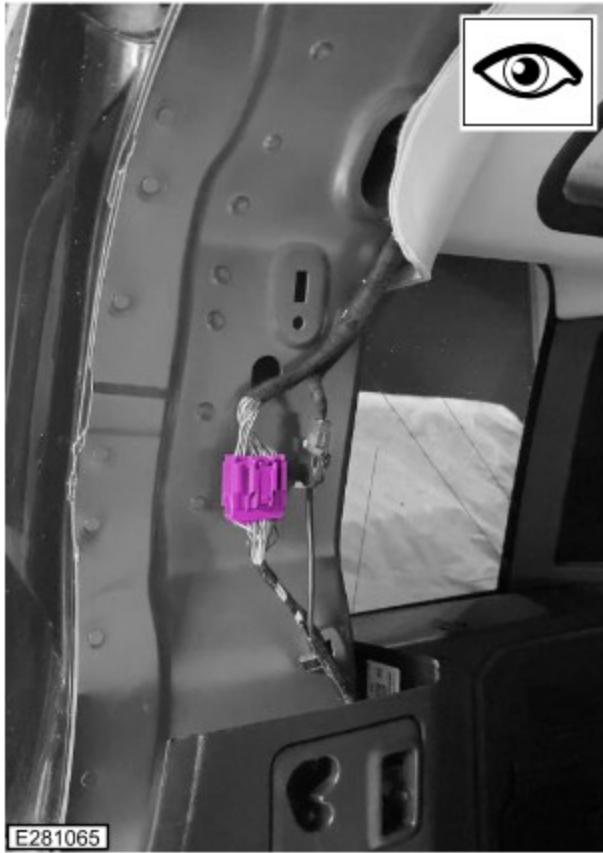
13.

Connect the electrical connector (C49D).

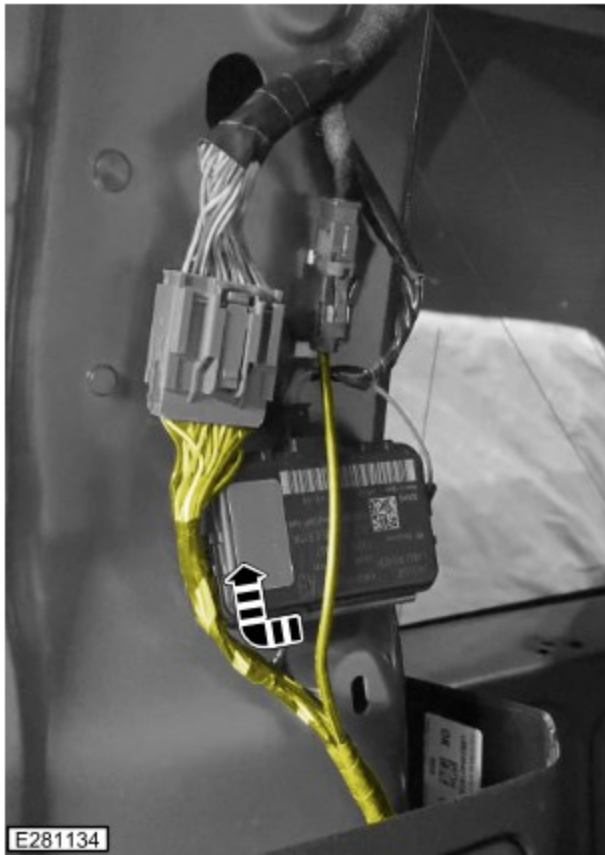
16.

Reposition the wiring harness and coax cable into the position shown in the illustration.

- The wiring harness must be routed around the left side of the RF receiver.
- The coax cable must be routed over the RF receiver.
