CLASSIC CARS TODAY ONLINE

The 1999-2004 Land Rover Discovery II: a look back at these modern classic SUVs

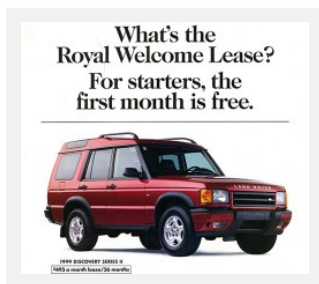
The second generation Land Rover Discovery was produced during the 1999 – 2004 model years. Shown, a 2004 Discovery SE7.
