C1339

CONNECTOR DETAILS

DISCOVERY SERIES II

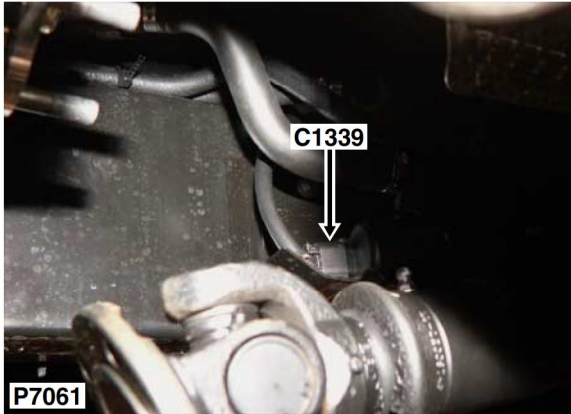
Cav	Col	Cct
1	KO	18
2	BY	18
3	NK	18

Description: *Pump-Leak detection*
Location: *Beneath vehicle - RH side*

Colour: *BLUE*
Gender: *Female*
