Information and Message Center - Information and Message Center

Description and Operation

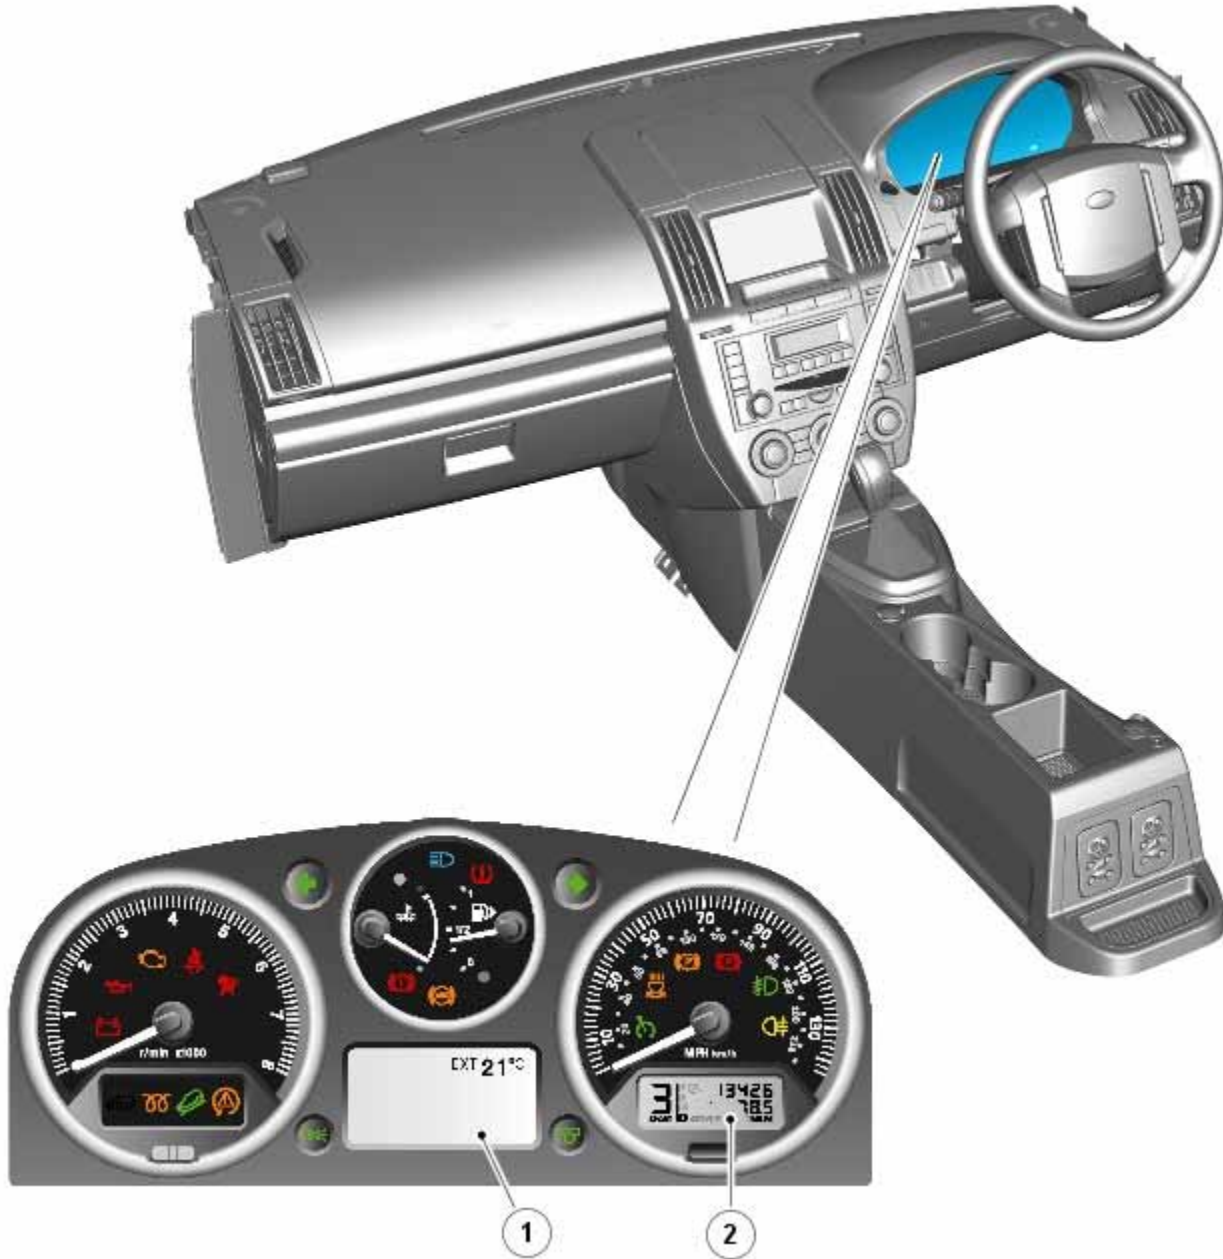
E76933

COMPONENT LOCATION

Item	Part Number	Description
1	-	Message center
2	-	Odometer

The message center is a Liquid Crystal Display (LCD) located in a central position in the instrument cluster. The message center displays system and vehicle status information to the driver.

The odometer is located in the speedometer and displays the total distance the vehicle has traveled. This is calculated using the same signal as that used for the trip meter.
